Flight - and Maintenance - Manual
for the Glider
AS - K 13

AS - K 13

Elevator.

Subject: Inspecting the bearing brackets and the toggle force of the airbrake control circuit.

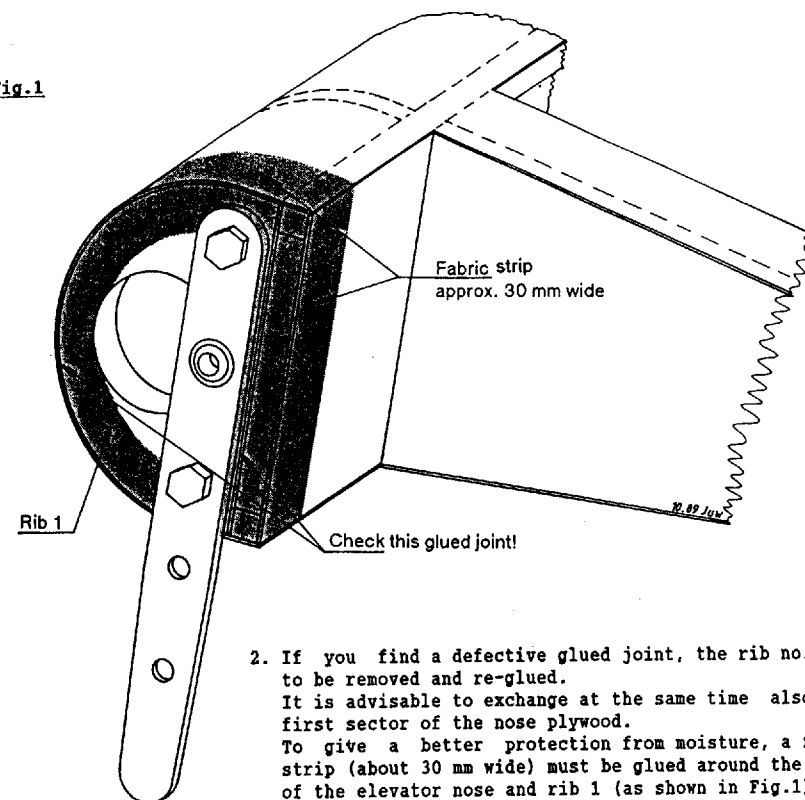
Fig.1

A glider of the model K7 failed to gain normal flight attitude immediately after tow rope release on winch launch. With the stick full back only the left elevator could be actuated in the correct direction; the right elevator deflected downwards. The reason for this was a loose glue bond at the elevator rib 1 at which the elevator fitting is attached. Similar incidents lead already before to the issue of the LTA 72-7 dated Feb.9,1972.

1. Remove elevator.
Check that the glued joint between rib 1 and the leading edge plywood and the elevator spar respectively is in good condition (see Fig.1). Before doing so check whether the LTA 72-7 of Feb.9, 1972 was already previously accomplished (this is not applicable to K9, K11 and ASK 18); if yes then the fabric strip first carefully has to be detached in order to be able to check the glued joint.

2. If you find a defective glued joint, the rib no.1 has to be removed and re-glued.
It is advisable to exchange at the same time also the first sector of the nose plywood.
To give a better protection from moisture, a fabric strip (about 30 mm wide) must be glued around the edge of the elevator nose and rib 1 (as shown in Fig.1).
3. The above action under points 1. and 2. must be repeated every three years during the annual re-inspection. This copy of the Technical Note must be inserted in the Flight and Operations Manual of the respective glider as an annex and a corresponding entry must be made into the "Amendments to the Manual".

Rib 1 made from multi-plywood, 15 mm thick, and nose plywood, 1 mm thick, according to DIN L 182/183, class 1/2 or NL 9128, 6.1013. Drawing as above.

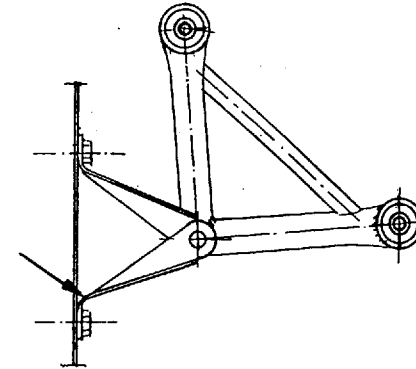
Material & drawings:

Reason: On some gliders of the model ASK 13 the bearing brackets of the airbrake control circuit have broken at the wing root rib. The failure was caused by too high toggle forces which resulted from a wrong adjustment of the toggle in the airbrake control circuit.

1. Carefully inspect the bearing brackets of the airbrake control circuit at the wing root ribs as well as the root ribs themselves for damage, cracks etc. In case of doubt the paint must be removed off the bracket. In most cases the breaks were found at the bottom of the front bearing bracket; refer to the drawing on Sheet 2 of this TN ! Where damages at one bearing bracket are found, this part must be exchanged; where a root rib is damaged, it requires repair.

2. Check the toggle force as described under Point 3.) and where necessary adjust.

- 3.2 The airbrake toggle - each side separately - must be adjusted such that a force of approx. 3 to 4 daN is obtained at the front airbrake operating lever when measured from above (measurement distance from the pivot point of the operating lever towards the hand grip = 300 mm).

- 3.3 Adjustment of the toggle force is done by turning in or out the adjusting heads in the fuselage. If the correct adjustment values cannot be achieved here, the thickness of the airbrake stop blocks inside the wings must either be increased or cut back.
